ADVANTAGES OF OXIDE FILMS AS BASES FOR ALUMINUM
PIGMENTED SURFACE COATINGS FOR ALUMINUM ALLOYS

By R. W. Buzzard and W. H. Mutchler
Bureau of Standards

TECHNICAL NOTE NO. 400

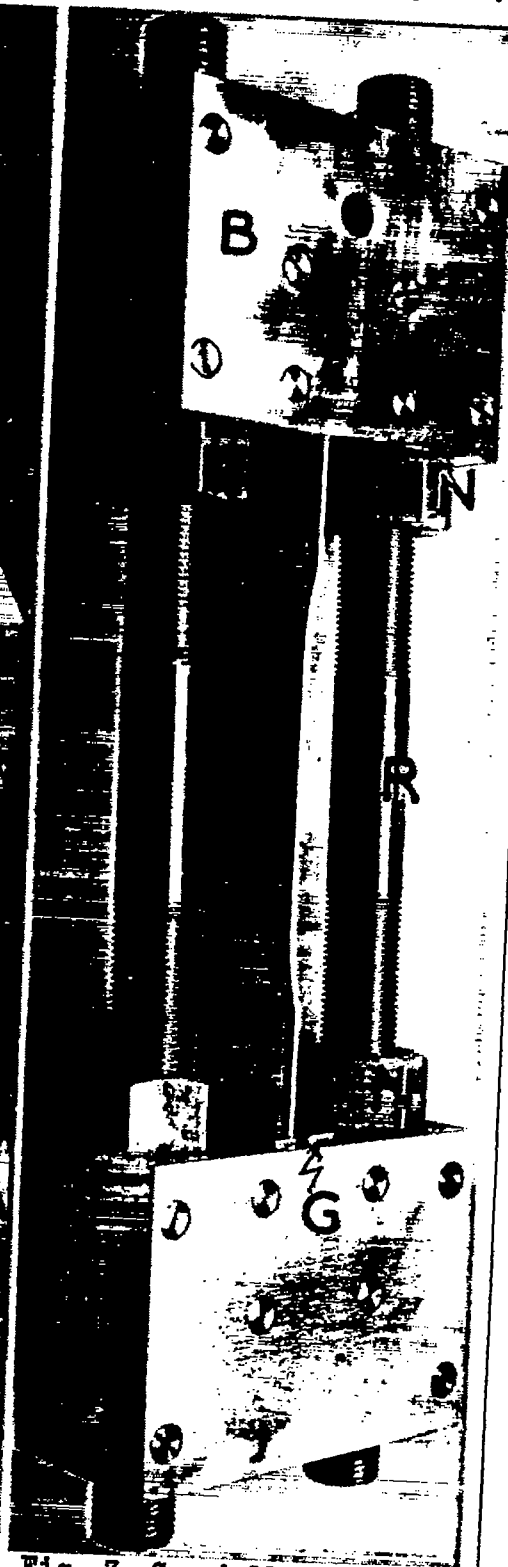
Fig. 3 Specially designed
grips for securing
static stress on specimens
during corrosion tests

No fundamental changes in the intermittent immersion method were necessary in order to corrode specimens under static tension, except that the apparatus sustaining the static load was substituted for the glass racks which ordinarily supported the specimens. The static tension apparatus was constructed of steel and was heavily coated with paraffin prior to corroding the specimen which it held. Reference to the photograph, (fig. 3), will serve to illustrate its operation. The load was applied to the specimen in an Amsler testing machine through the end blocks B-B' and the grips G-G', the four nuts N not being in contact with the end blocks. When the desired load was recorded on the Amsler machine the nuts N were tightened until the load on the Amsler registered zero, the rods R-R' then sustaining the load.
